**Re: Weitsman Shredding, LLC d/b/a Upstate Shredding, LLC  
Compliance Evaluation Inspection – August 4, 2015  
SPDES Tracking No. NYR00D022**

**COMPLIANCE EVALUATION INSPECTION REPORT**

<b>Compliance Evaluation Inspection:</b> Weitsman Shredding, LLC d/b/a Upstate Shredding, LLC
<b>Inspection Date:</b> August 4, 2015 <b>Inspection Time:</b> 1:00 PM – 6:00 PM
<b>EPA Inspector:</b> Katherine Mann, Physical Scientist, USEPA Region 2, DECA, Water Compliance Branch (212) 637-4226
<b>On-Site Representative:</b> Adam Weitsman, Owner, Office: (607) 687-7777, Cell: (607) 760-8204
<b>Site Information:</b> 1 Recycle Drive, Owego, NY 13827; SPDES No. NYR00D022
<b>Owner/Operator/Permittee:</b> Weitsman Shredding, LLC  Adam Weitsman, Owner, P.O. Box 420, Owego, NY 13827
<b>SIC Code:</b> 5093 (Scrap and Waste Materials)

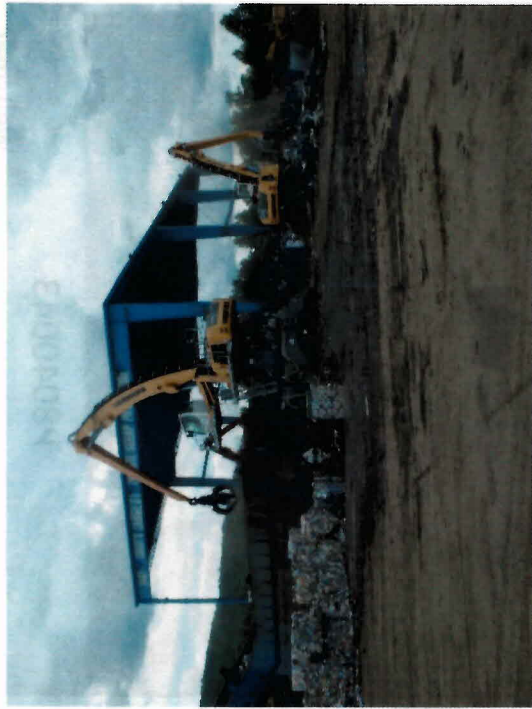
P8040037

15. As identified in photograph P8040037, scrap storage in the center of the Site (west of the shredder) is exposed to stormwater and is a potential source of pollutants to the on-site stormwater treatment pond. In addition, aluminum and steel piles on the south side of the shredding area are located in an exposed area where stormwater flows to the pond (see photographs P8040042 and P8040051). Due to the removal of the stone perimeter swale, there are currently no structural BMPs (e.g., containment or diversion structures) in place to minimize the transport of pollutants from these sources to the pond, which discharges to Outfall 001.
16. As identified in photographs P8040059 – P8040061 and P8040064, sediment build-up and some discoloration were observed at the weir at Outfall 001. As identified in P8040064, a sheen was observed in the sediment at the weir.

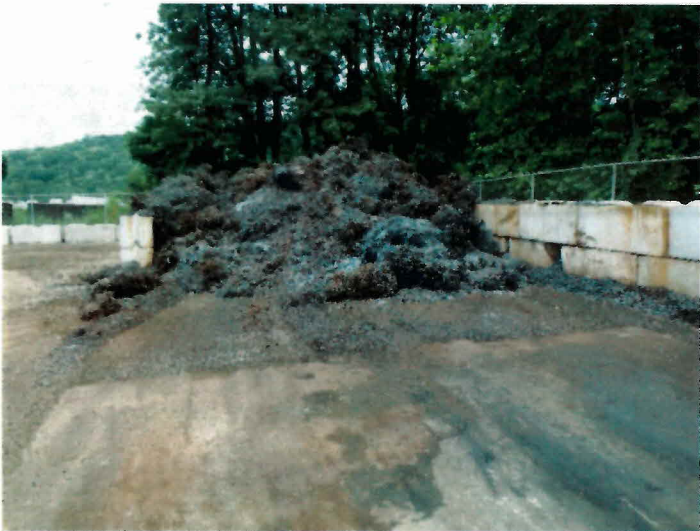
P8040043

6. As identified in photographs P8040043, the turnings pile in the southeast corner of the Site was not covered at the time of the CEI. In an email dated August 7, 2015, Mr. Weitsman indicated that the turnings pile had been covered. This was confirmed with photo documentation on August 10, 2015. The Facility must ensure all turnings are stored in covered bins or in bermed areas and covered with tarps, in accordance with the SWPPP and Parts III.A and VIII (Sector N) of the MSGP.

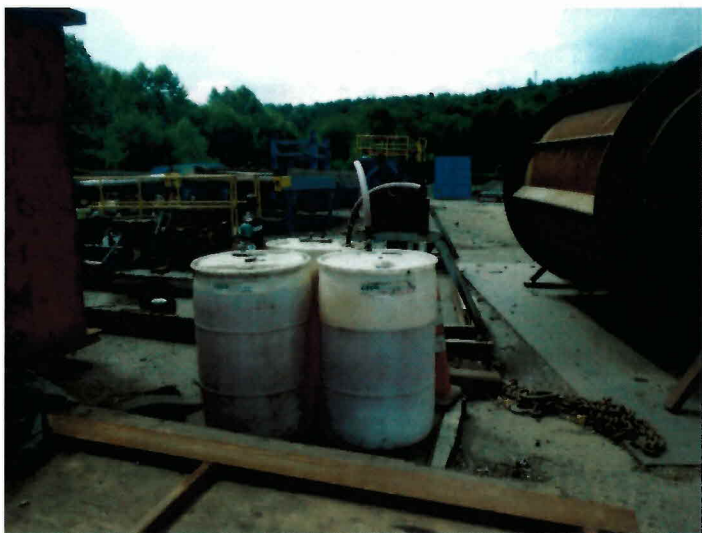
P8040057

10. As identified in photographs P8040057, three (3) 55-gallon drums of antifreeze were identified on the south side of the Site at the time of the CEI in an area exposed to stormwater. The drums were moved under the adjacent roofed structure prior to the close of the CEI (see photograph P8040139). The Facility must ensure drums containing liquids are stored indoors whenever practicable and are stored with containment devices such as spill pallets, in accordance with the SWPPP and Parts III.A and VIII (Sector N) of the MSGP.

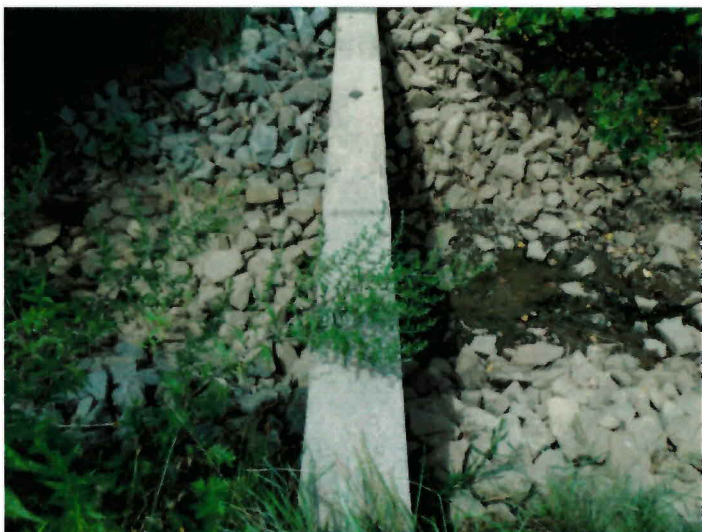
P8040059	Weir at Outfall 001 (with sediment build-up on pond side of the weir)
P8040060	Discoloration at low flow discharge point from the weir
P8040061	Close-up of discoloration at low flow discharge point from the weir
P8040062	Rip rap downstream of Outfall 001 (Owego Creek is located beyond the fence line)
P8040063	Sediment build-up on pond side of the weir
P8040064	Close-up of sediment with sheen on the pond side of the weir (at Outfall 001)
P8040065	Spill observed on the ground just north of the stormwater pond
P8040129	55-gallon drums containing various liquids stored outdoors on the northwest side of the Site. Some of the drums were situated in a secondary containment structure, and others were stored without secondary containment.

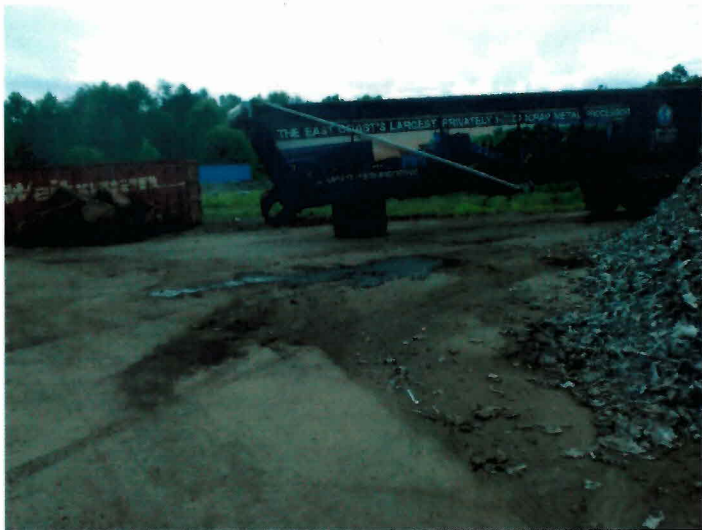
P8040065

7. As identified in photograph P8040065, an oil spill was identified on the ground towards the west side of the Facility, north of the pond. Absorbent material was applied to the spill before the close of the CEI (see photograph P8040138). Please ensure spills and leaks are promptly cleaned up, in accordance with the SWPPP and Parts III.A and I.B.1.a.(2).(a) of the MSGP.

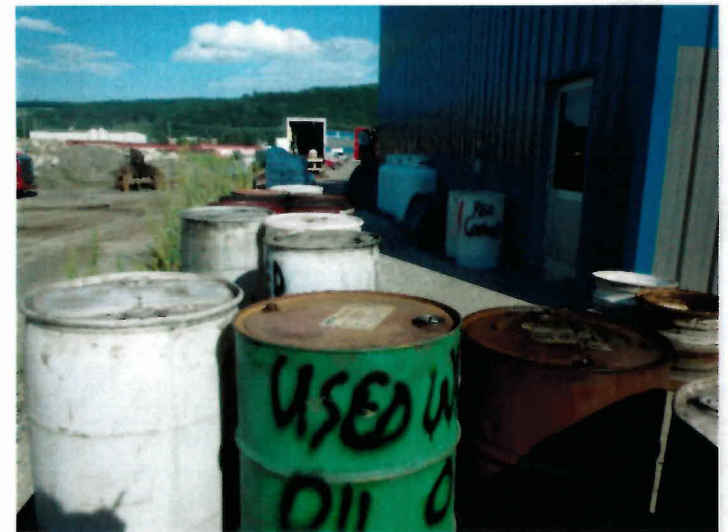
P8040129

9. As identified in photograph P8040129, several 55-gallon drums with various contents were stored outside the new maintenance garage where they were exposed to stormwater. Some of the drums were placed in a secondary containment structure, whereas others were stored without secondary containment. On August 17 and 18, 2015, Mr. Weitsman provided photo documentation of the drums, which had all been placed in a secondary containment structure and covered with a tarp. The Facility must ensure drums containing liquids are stored indoors whenever practicable (or covered so that they are not exposed to stormwater) and are stored with containment devices such as spill pallets, in accordance with the SWPPP and Parts III.A and VIII (Sector N) of the MSGP.

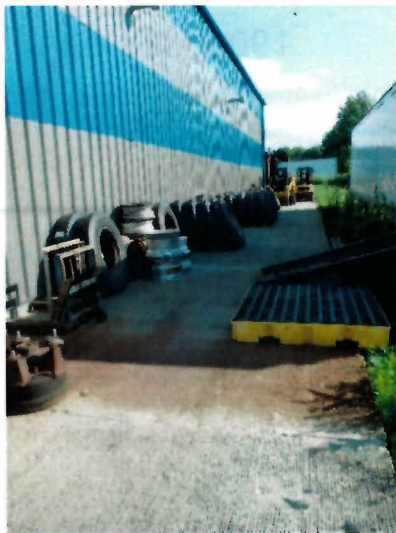
13. As identified in photograph P8040130, tires were stored outdoors on the northwest side of the Facility at the time of the CEI. Tires should be stored in areas where they are not exposed to stormwater to prevent the transport of associated pollutants to surface and ground waters. In an email dated August 17, 2015, Mr. Weitsman provided photo documentation of a metal shed being utilized for tire storage at the Site.
14. As identified in photographs P8040133 and P8040134, paint cans and miscellaneous metal parts were stored outdoors next to the drainage ditch leading to Outfall 002 at the time of the CEI. These items should be stored indoors to prevent the transport of associated pollutants to surface and ground waters. In an email dated August 7, 2015, Mr. Weitsman indicated that the paint cans had been discarded.

P8040130	Tires stored outdoors on the west side of the new maintenance garage (northwest side of the Site)
P8040131	55-gallon drums of coolant, tires, and other materials stored on wooden pallets on the north side of the new maintenance garage
P8040132	Culvert in the ditch that drains west to Outfall 002. Some sediment accumulation was observed in the ditch at the time of the CEI.
P8040133	Miscellaneous paint cans and metal parts stored outdoors just north of the drainage ditch near the new maintenance garage
P8040134	Empty paint cans in trash receptacle stored outdoors just north of the drainage ditch near the new maintenance garage
P8040135	Downstream end of culvert pipe identified in P8040132, with vegetated drainage path to Outfall 002
P8040136	Leaking heavy equipment stored outdoors, without drip pan, on the west side of the Site
P8040137	Leaking heavy equipment stored outdoors, without drip pan, on the west side of the Site; additional staining to the pavement in the foreground

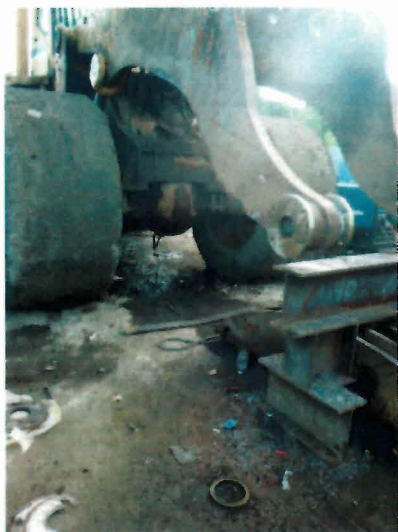
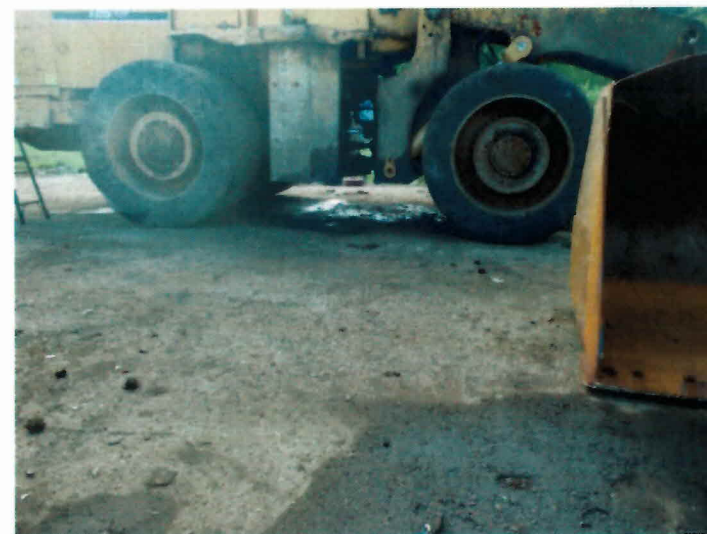
8. As identified in photographs P8040136 and P8040137, a leaking piece of heavy equipment was observed on the west side of the Site at the time of the CEI. In an email dated August 7, 2015, Mr. Weitsman indicated that this area had been cleaned up and the equipment moved. A photograph showing the cleaned area was provided by Mr. Weitsman on August 10, 2015. The Facility must perform equipment maintenance inside, whenever possible, utilize drip pans for leaky equipment, and promptly clean up any releases, in accordance with the SWPPP and Parts III.A, VIII (Sector N) and I.B.1.a.(2).(a) of the MSGP.

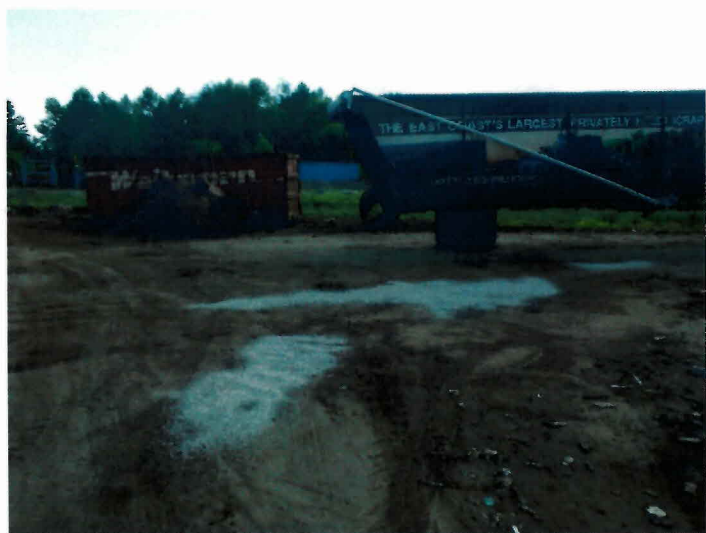
P8040138	Prior to the close of the CEI, speedy-dry was applied to the spill identified in photograph P8040064.
P8040139	Prior to the close of the CEI, the antifreeze drums identified in photograph P8040057 were relocated under an awning.
P8040140	South side of the Site (facing east)
P8040141	Employees covering aluminum and steel piles near the shredder with tarps (the employees had mistaken these piles for the turnings pile, which Mr. Weitsman had requested be covered during the CEI)
P8040142	240-gallon hydraulic oil tank, and housekeeping issues inside old maintenance garage (drums stored without secondary containment, staining observed on garage floor)
P8040143	Additional drums stored in the old maintenance garage without secondary containment
P8040144	Close-up of pooled antifreeze on top of a 55-gallon drum in the old maintenance garage
P8040145	500-gallon used oil tank stored outside the old maintenance garage under a roof; 55-gallon drum on the left was stored without secondary containment

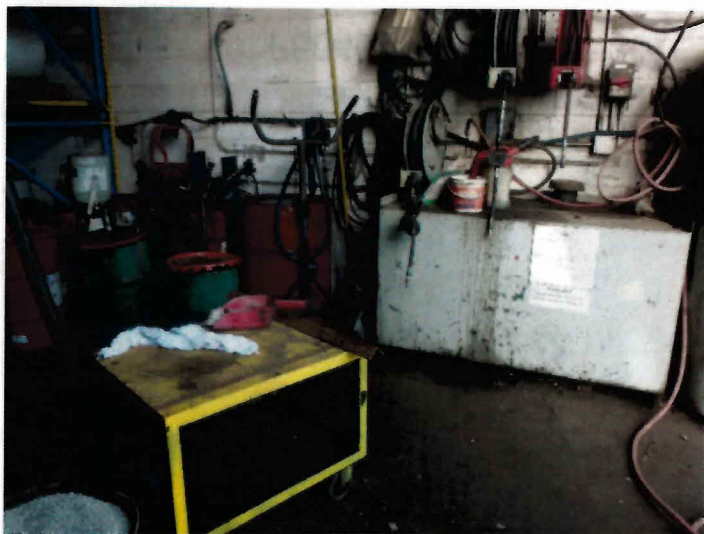
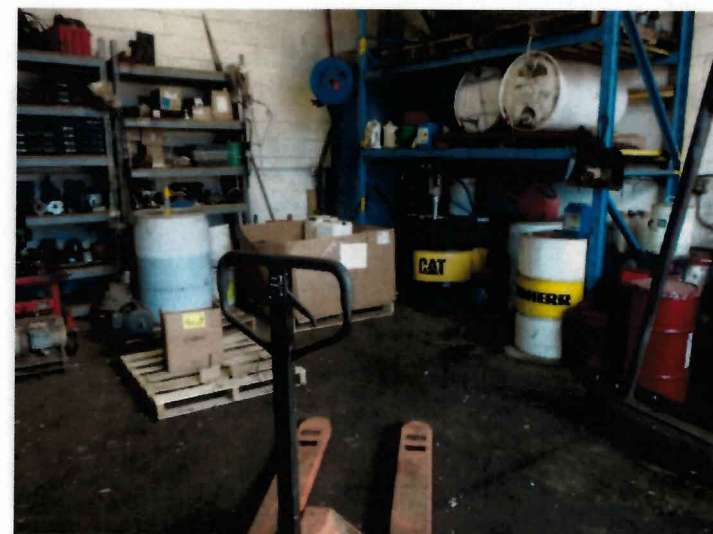
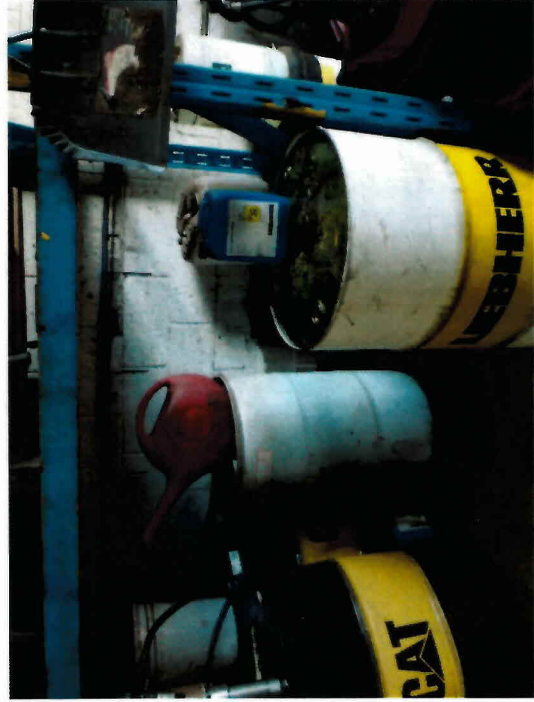
11. As identified in photograph P8040142 – P8040144, good housekeeping issues were observed inside the old maintenance garage, including storage of drums without secondary containment, staining to the garage floor, and pooled antifreeze on top of a 55-gallon drum. In an email dated August 7, 2015, Mr. Weitsman indicated that the old maintenance garage had been cleaned and organized. A photograph was provided on August 17, 2015 documenting that the drums had been placed on spill pallets and the garage floor had been cleaned. The Facility must ensure drums containing liquids are stored with containment devices such as spill pallets, in accordance with the SWPPP and Parts III.A and VIII (Sector N) of the MSGP.

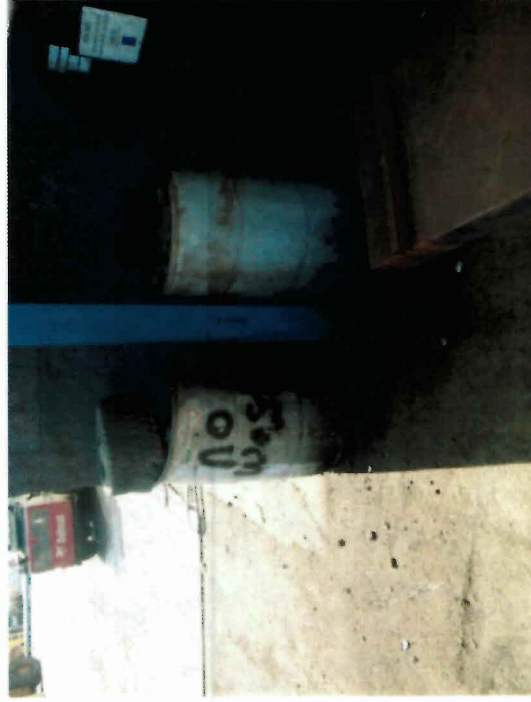
12. As identified in photograph P8040146, two (2) 55-gallon drums were observed outdoors, (although mostly under a roofed area), next to the old maintenance garage. Drums containing liquids must be stored indoors whenever practicable and with containment devices such as spill pallets, in accordance with the SWPPP and Parts III.A and VIII (Sector N) of the MSGP.

P8040146	Two (2) 55-gallon drums stored outside the old maintenance garage without secondary containment
